Memorandum

Subject: Summary of sediment sampling and probing effort: LPR River Mile 10.9 and adjacent

areas (September 29, 2015), Lower Passaic River Restoration Project

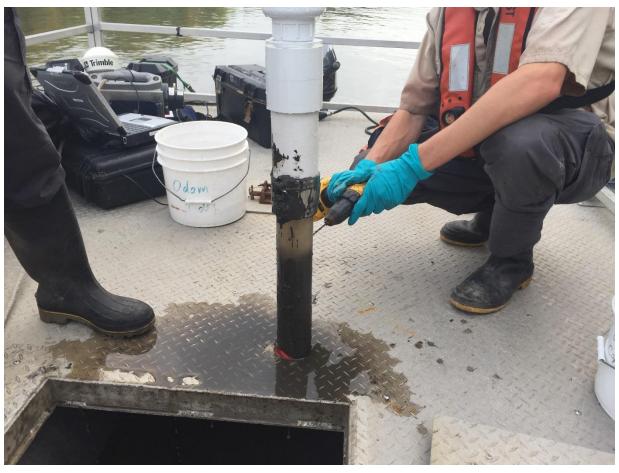
Sample Location	Coring Attempt at Location	Approximate Core Recovery	Notes
PRSS-01	1	10-in of sediment with no discernable sand layer	Most northernmost coring location
PRSS-02	1	1-in of sediment above sand layer	Core contents returned to site
	2	8-in of sediment above 6-in of sand	Core was decanted by pouring overlying water from the coring tube; sediments appear cohesive and compacted

Photo 2 - PRSS-01 sediment core (9/29/2015)

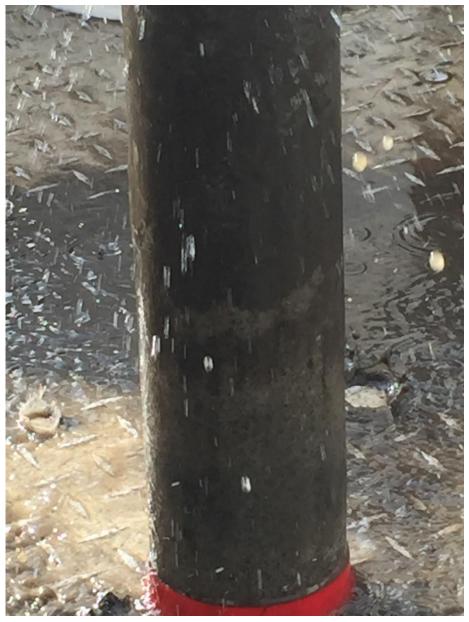
Photo 3 - PRSS-02 sediment core (second coring attempt; sediment underlain by discernable sand layer) (9/29/2015)

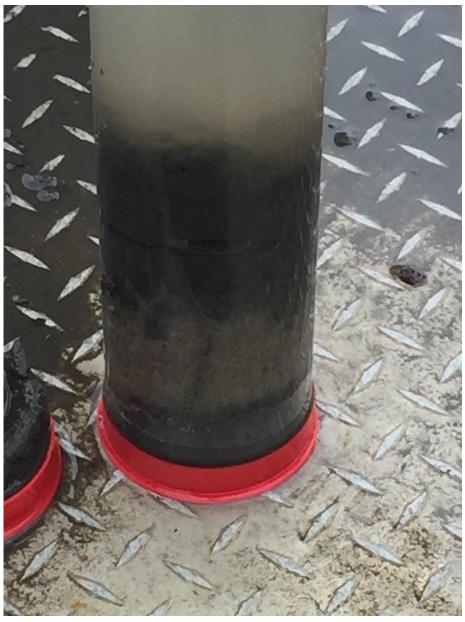
Photo 5 - Example of limited sediment above sand layer at PRSS-06 (9/29/2015)

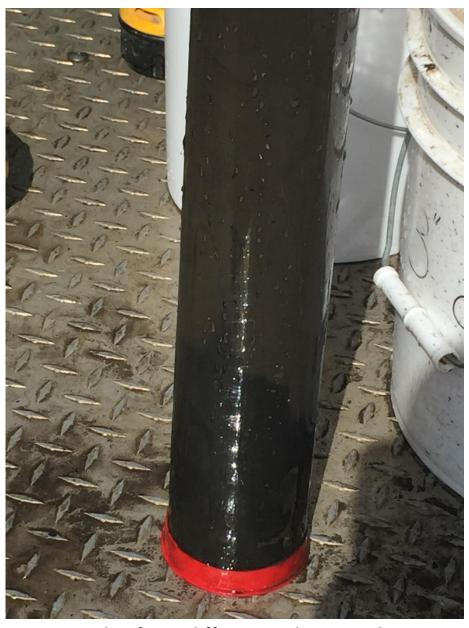
Sample Location	Coring Attempt at Location	Approximate Core Recovery	Notes
PRSS-08	1	18-in of sediment with no discernable sand layer; bottom 6-in of sediment appear darker than top 12-in	core collected along riverbank opposite of RM 10.9 cap
PRSS-09	1	8-in of sandy material	core collected along riverbank opposite of RM 10.9 cap; core location near suspected CSO; NOTE: field log mistakenly labels this location as a second location "8" (entry at 1052)

Photo 6 - Example of two different sediment colors at PRSS-08 (9/29/2015)

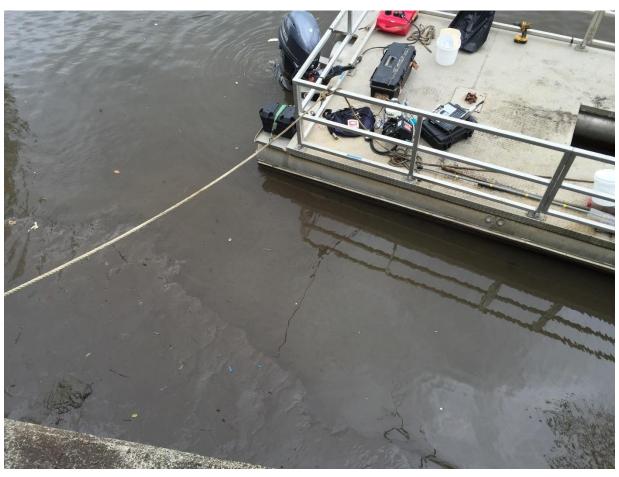
Photo 8: Example of difficulties in retrieving sample vessel due to lowering water levels

As a general note for future consideration, tidal fluctuations and decreasing water levels should be monitored during any on-water field activities at the site. Low water levels nearly prevented the retrieval of the Aqua Survey vessel from the Passaic River at the conclusion of the September 29th field activities (see Photo 8).
